STANTON COMMUNITY SCHOOLS

FACILITY ASSESSMENT
605 ELLIOTT ST
STANTON, IA 51573

August 4, 2023

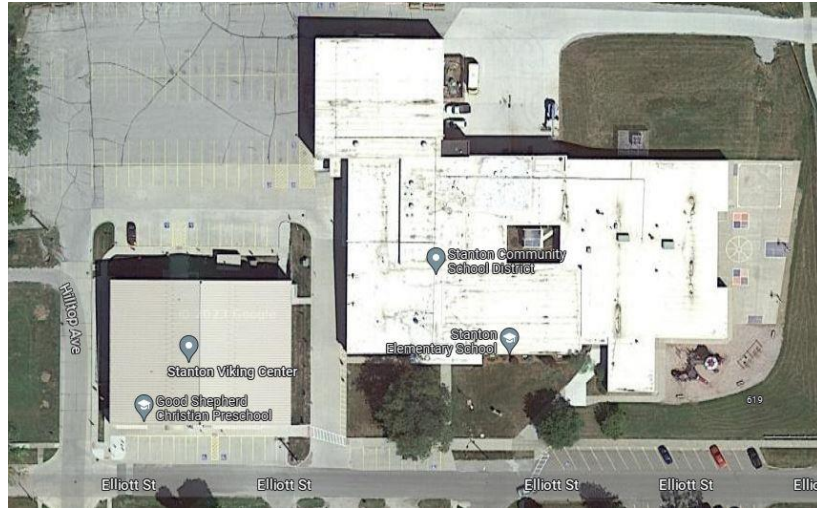
PHOTO A1

- The northwest parking lot by the gym is in poor condition. It has large cracks throughout the parking lot and has had sealant previously applied. The cracks are widespread making patching/repairs difficult.
- The parking lot to the east of the gym and drive is newer and in good condition.
- The concrete playground to the east of the elementary had some minor cracks and is in overall fair condition.
- The entry sidewalk to the elementary and a section of the front sidewalk to the south have been replaced and are in good condition. The rest of the sidewalks have some cracks and are in fair condition.

DESCRIPTION:
North West Parking lot Arial Cracks.

- Consider replacing the Northwest parking lot.
- Consider roof replacement.
- Consider replacing non-ADA compliant door hardware.
- Consider replacing the worn out / stained carpet.
- Consider replacing the sagging / water stained acoustical ceiling tiles.

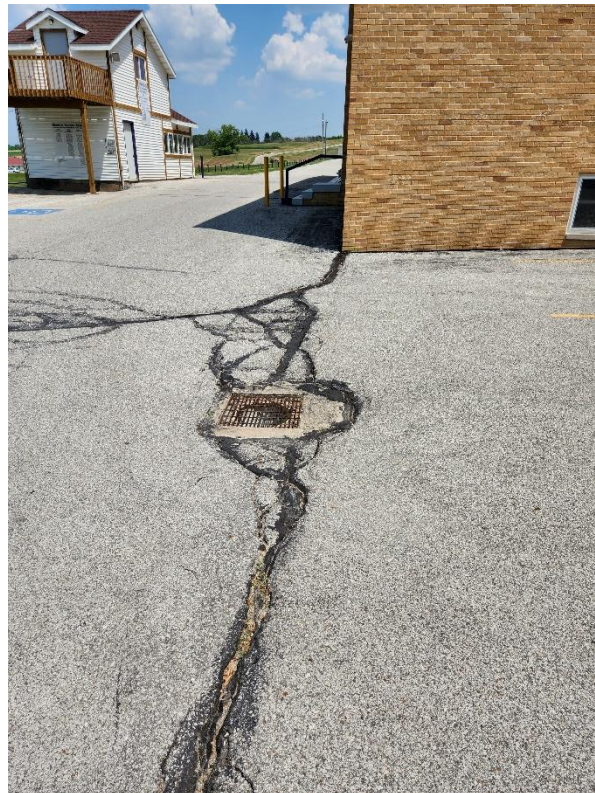
PHOTO A2

DESCRIPTION:
Parking lot crack.

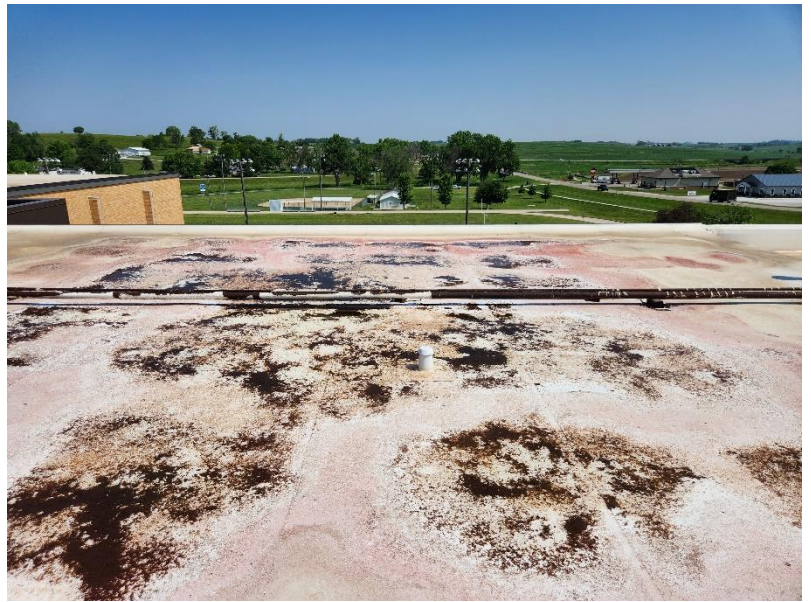
PHOTO A3

- The north section had ponding water at the time of visit and other sections showed evidence of ponding water in the past. Prolonged ponding can cause premature deterioration in single ply roofing systems such as this.

DESCRIPTION:
Ponding water on roof.

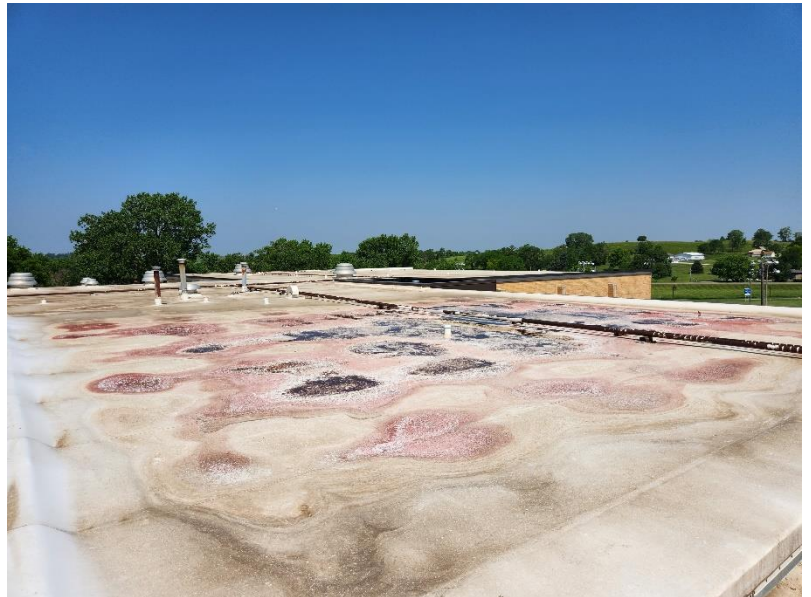
PHOTO A4

DESCRIPTION:
Ponding water on roof.

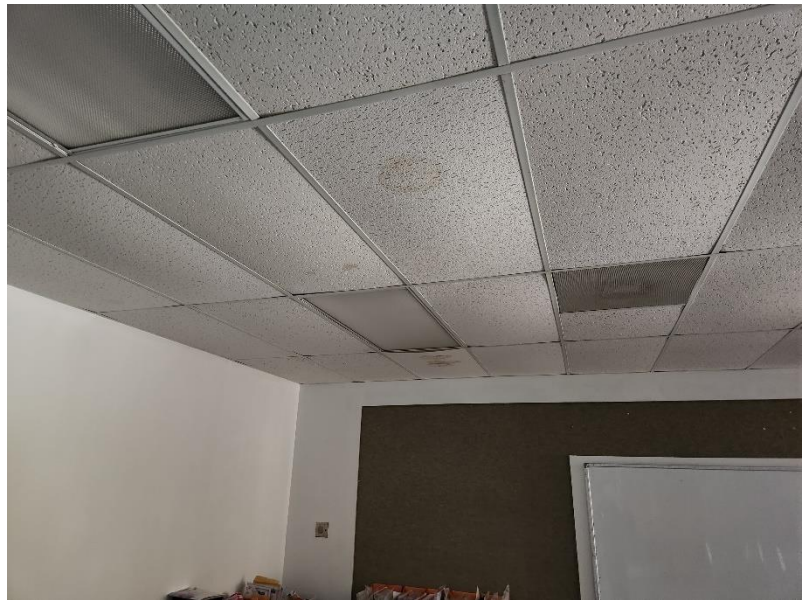
PHOTO A5

- The ceilings tiles are in average to poor condition. The ceiling tiles are starting to sag and have stains/scuffs/damage.
 - Ceiling tiles typically have an expected useful life of around 20-30 years. The grid can last much longer but is subject to discoloring and minor damage.

DESCRIPTION:
Ceiling tile stains.

- Replacement of sagging, stained, or damaged tiles may be considered for future routine maintenance.
 - When the tiles are replaced, consideration should be given to converting the ceilings with a 2'x4' metal grid to a 2'x2' metal grid. 2'x2' ceiling tiles tend to perform better over time and exhibit less sagging.

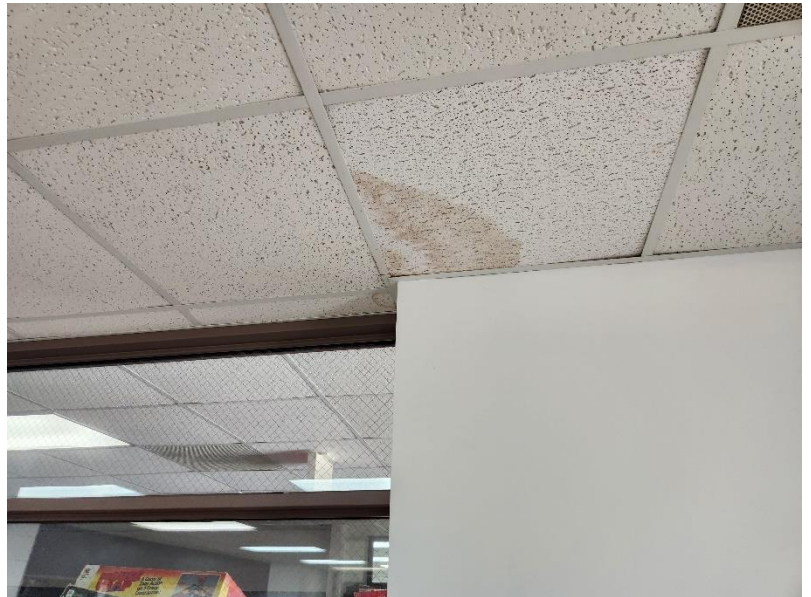
PHOTO A6

DESCRIPTION:
Ceiling tile stains.

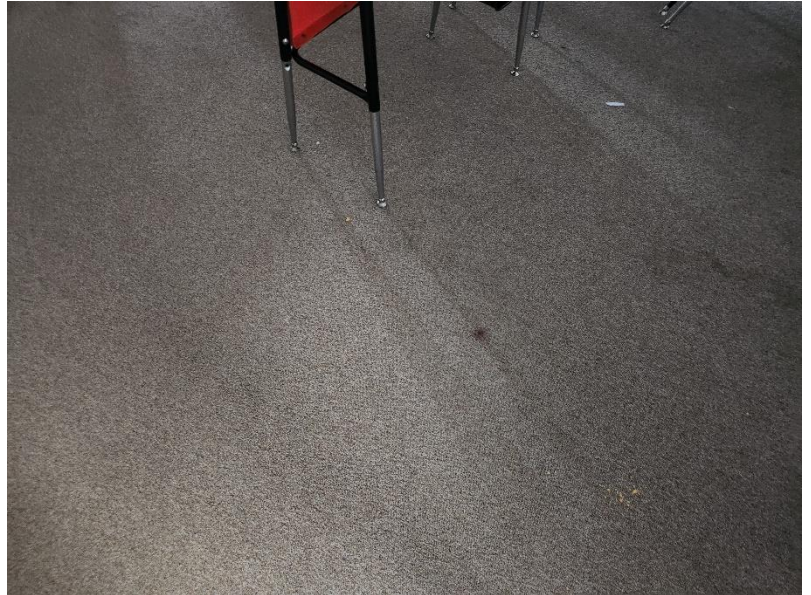
PHOTO A8

- The corridors and classrooms throughout the building were a combination of carpet and vinyl composition tile. The carpet was showing signs of wear and had stains in several locations.

DESCRIPTION:
Worn carpet.

- The life expectancy of carpet is 7 to 15 years if it is well maintained and of good quality. Flooring should be reviewed and replaced during routine building maintenance.

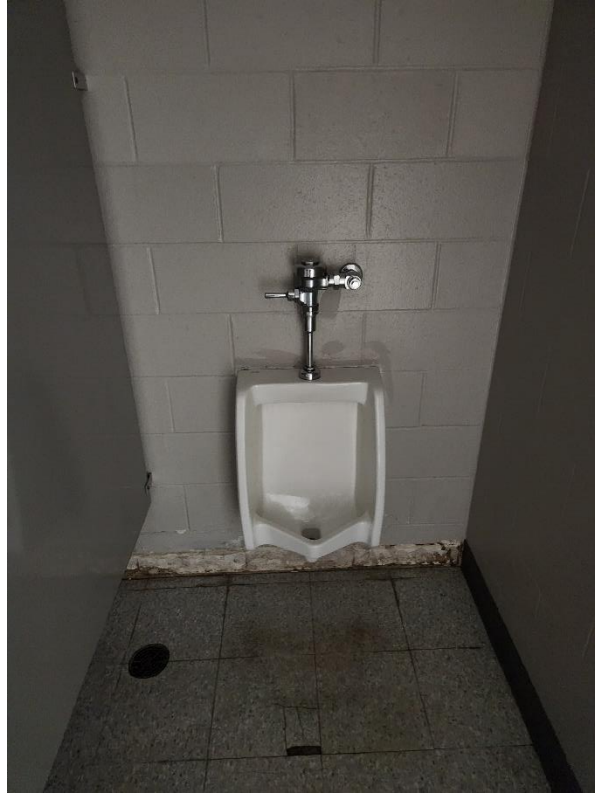
PHOTO M1

Bathroom cracked tile & missing base.

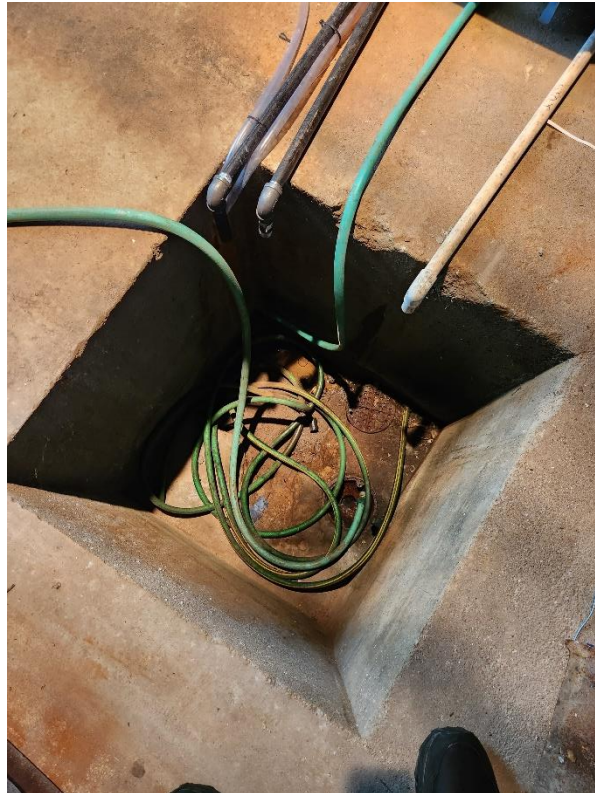
PHOTO M2

Boiler pit for condensate and relief discharge.

- Reroute the dryer exhaust vent located in the family and consumer science classroom to the exterior.
- Insulate piping in the high school boiler room and provide adequate intake opening for combustion air.
- Scope drain line in boiler pit to determine the condition of waste piping. Replace drain line as required. Repair pit concrete for proper drainage.
- Replace elementary loop pump number one.
- Regularly run water through high school restroom fixtures and floor drains to eliminate sewer smell.
- Scope roof drains with tape to determine if the pipe is disconnected or broken. Replace piping as required.

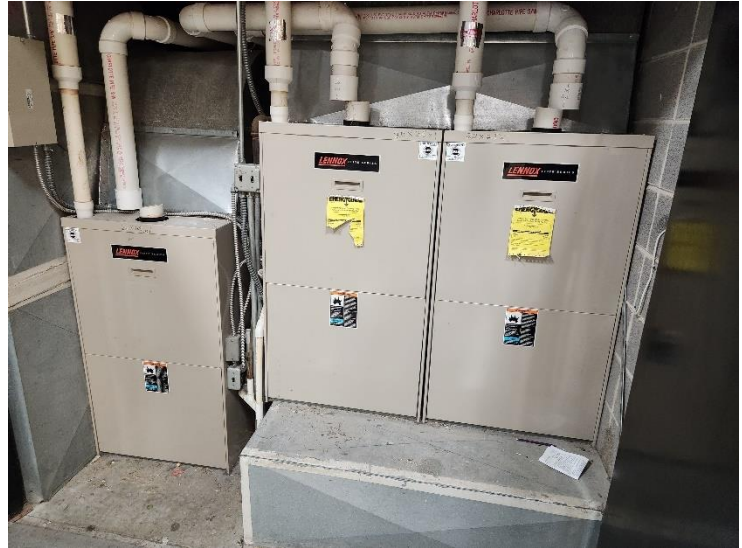
PHOTO M3

- The gym is served by three 125 mbh Lennox furnaces in a closet on the stage and are from 1996. The life expectancy of gas fired furnaces per ASHRAE is 18 years. The gym does not have any air conditioning or ventilation. The gym furnaces are beyond its useful life. Furnaces can be replaced and ventilation/cooling added or another unit such as a rooftop unit can be installed.

DESCRIPTION:
Furnaces serving Gymnasium.

- Replace three furnaces serving the gymnasium. Code required ventilation should be added when replaced.
- Replace shut-off valves with corrosion for the high school boiler room.
- Replace or refurbish Mcquay air handling unit serving elementary.
- Replace air-cooled condensing unit for elementary AHU.
- Replace three boilers serving elementary.
- Replace elementary pneumatic control system with DDC.
- Replace exhaust fans.
- Replace make-up air unit serving locker rooms.
- Replace exhaust fans (10).
- Replace gas piping.
- Replace 80-gallon water heater in the basement mechanical room, elementary water heater, and locker room water heater.
- Replace shower heads in locker rooms.
- Replace elementary faucets with corrosion.

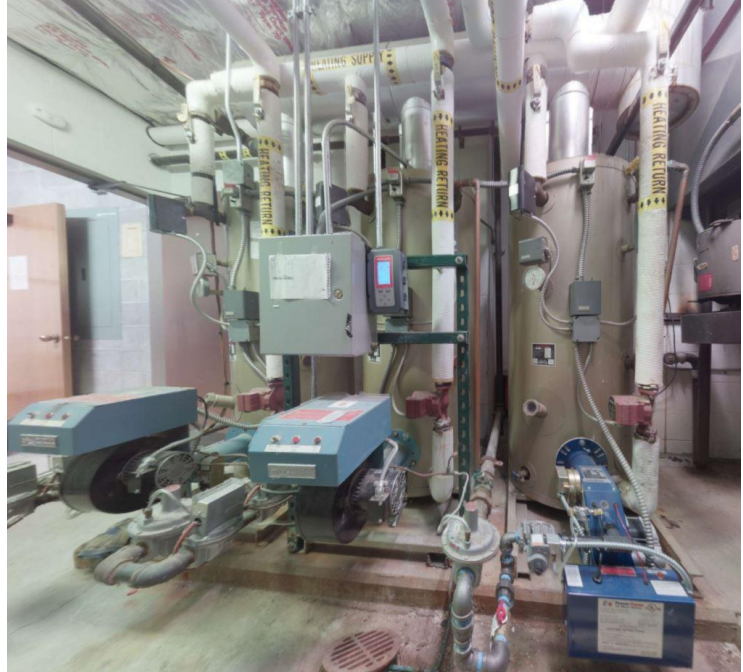
PHOTO M5

- The elementary is heated and cooled from a VAV reheat system. Bob reported one of the boilers has had a lot of maintenance issues. One of the boilers has had the gas train replaced. These boilers are beyond their useful life of 25 years per ASHRAE and should be replaced. Loop pump number 1 is not currently working according to Bob. Pump #2 has been replaced in the last 5 years.

DESCRIPTION:
Elementary Boilers.

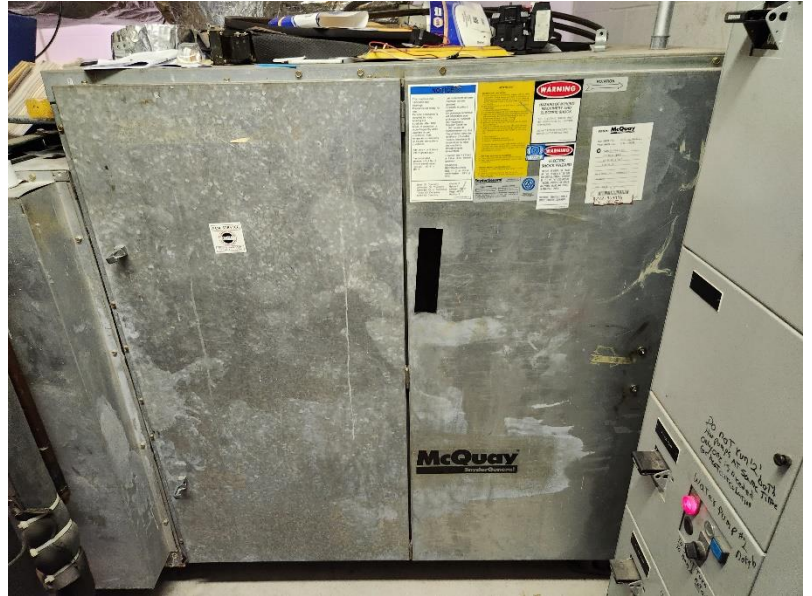
PHOTO M7

- One McQuay air handling unit (AHU) with a 15 hp fan serves the entire elementary. Bob reported the AHU has control issues sometimes. The coil has some damage to the fins and the drain pan is showing signs of corrosion. The AHU is original from 1991. Fans have an equipment life of 25 years and coils are 20 years. The AHU is beyond its useful life and should be replaced or refurbished. The AHU has a 60-ton Carrier air-cooled condensing unit for cooling. The condensing unit is past its useful life of 20 years.

DESCRIPTION:
AHU serving entire elementary.

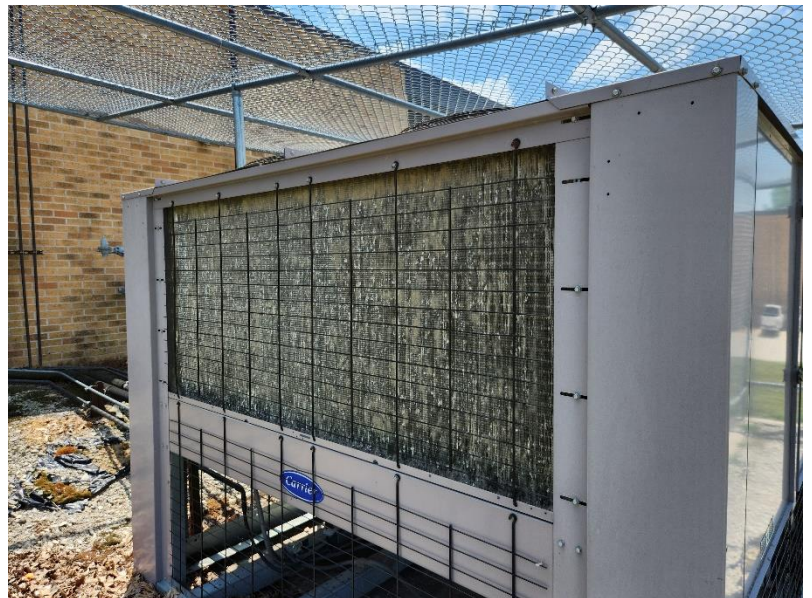
PHOTO M8

DESCRIPTION:
60 ton air cooled condenser. Unit serves elementary AHU (M7).

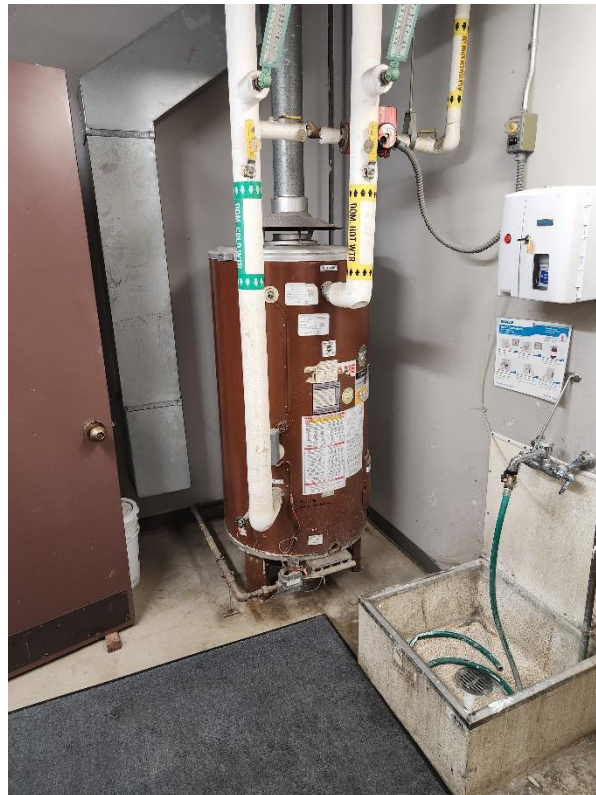
PHOTO M12

- The elementary is served by a 75-gallon natural gas water heater from 1992. This is past its useful life.
- The storage building has a six-gallon electric AO Smith water heater in good condition.

75 gallon gas water heater serving the elementary (1992).

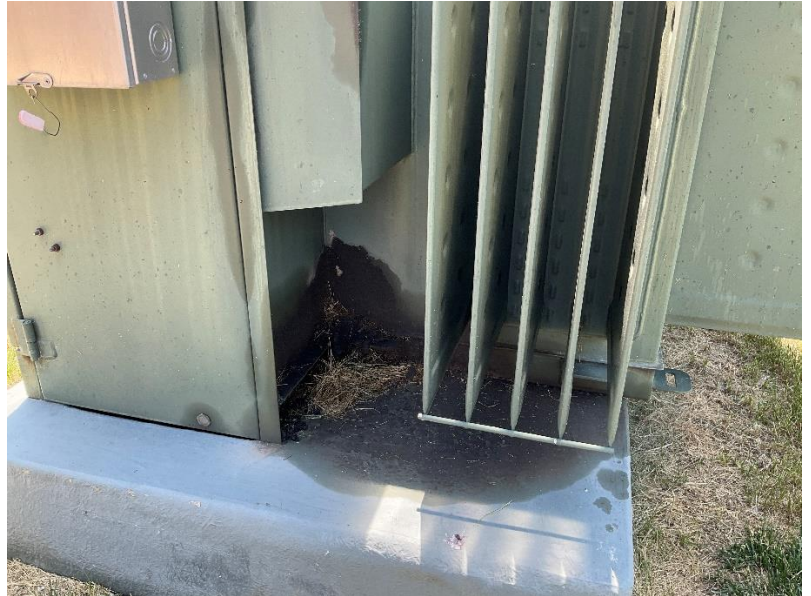
PHOTO E1

- The school's electrical service is fed underground from an existing pad-mount transformer owned by the Southwest Iowa Rural Electric Cooperative. The transformer provides a 120/208V, 3-phase, 4-wire electrical service to the 1969 portion of the facility through a 1200A fusible main switch and switchboard located in the kitchen receiving area. The utility meter, socket, and CTs are located on the transformer enclosure. Evidence of leaking was found at the base of the transformer. (Photo E1).

Evidence of leaking at the utility pad-mount transformer.

- Work with local electrical utility to replace leaking pad-mount transformer serving school.
- Replace existing branch circuit panelboards that are original to the 1969 building. Provide new feeder conductors to serve new panels in the same location.

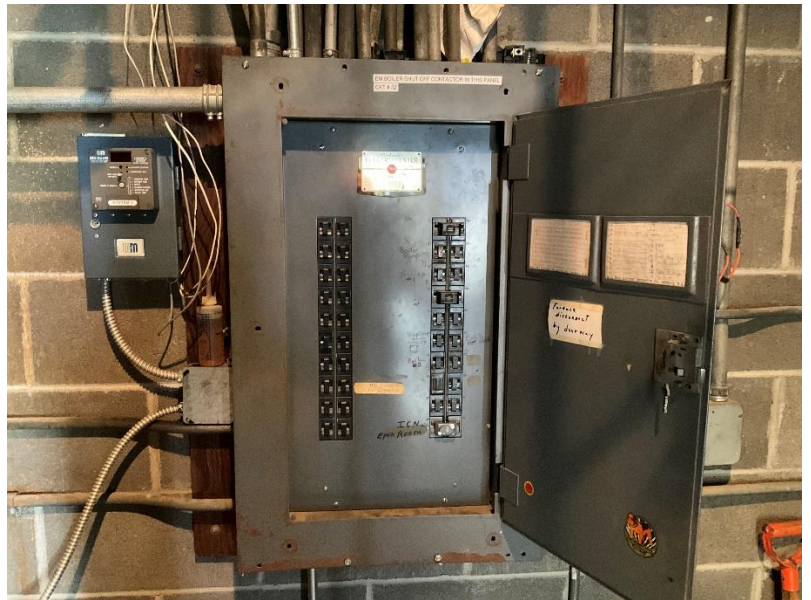
PHOTO E2

- There are several branch circuit panelboards throughout the existing facility that are original to the 1969 building and appear to be in poor condition. Replacement parts for these panels are obsolete or no longer available on the market, if required, for any associated renovation work. However, there are distribution panels and panelboards that have been replaced with renovation or building addition projects from the 1990s and 2000s. Most of this equipment appears to be

Existing panelboard type original to the 1969 building.

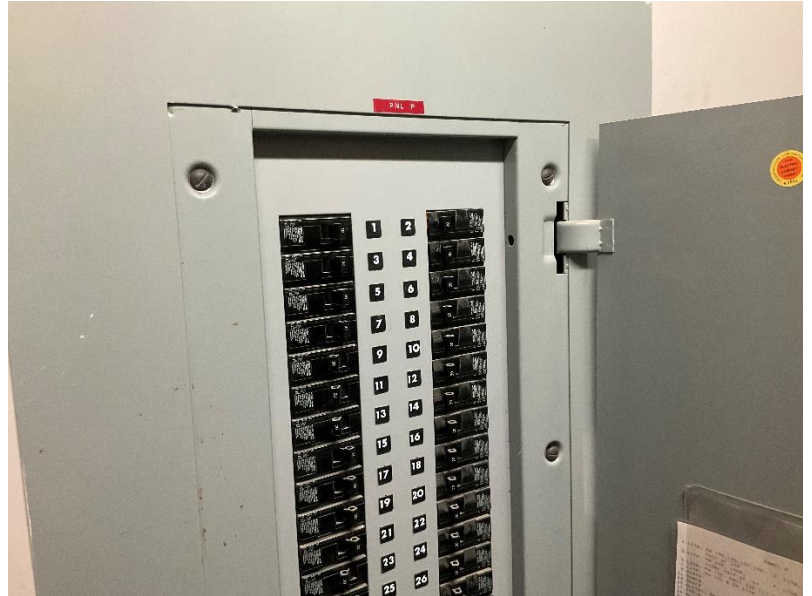
PHOTO E3

- The distribution equipment within the newer 1990 elementary addition is in good condition and dates to the 1990s and 2000s. Phenolic labels and typed panel schedule directories were observed on most of this equipment. (Photo E3).

Existing panelboard type provided under 1990 building addition.

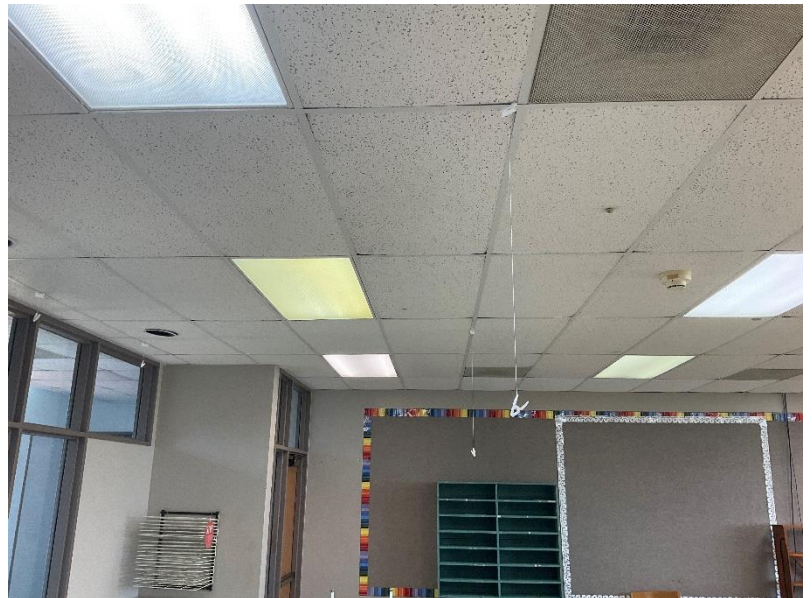
PHOTO E4

- Most of the lighting in the facility consists of 2x4 troffers and linear style fluorescent light fixtures with a mixture of 2-lamp, 3-lamp, and 4-lamp F32T8 varieties throughout the main corridors, lobbies, classrooms, cafeteria, and locker room spaces. A small number of incandescent and compact fluorescent recessed downlights were noted in some of the classrooms, lobbies, and locker rooms. (Photo E4).

Typical classroom with 2x4 recessed fluorescent troffer style light fixtures with varying lamp color temperatures.

- Replace or relamp existing light fixtures throughout facility that are not operational, have damaged or missing lenses, or have lamps with mismatched color temperatures. Clean existing light fixtures that contain debris and dirt.

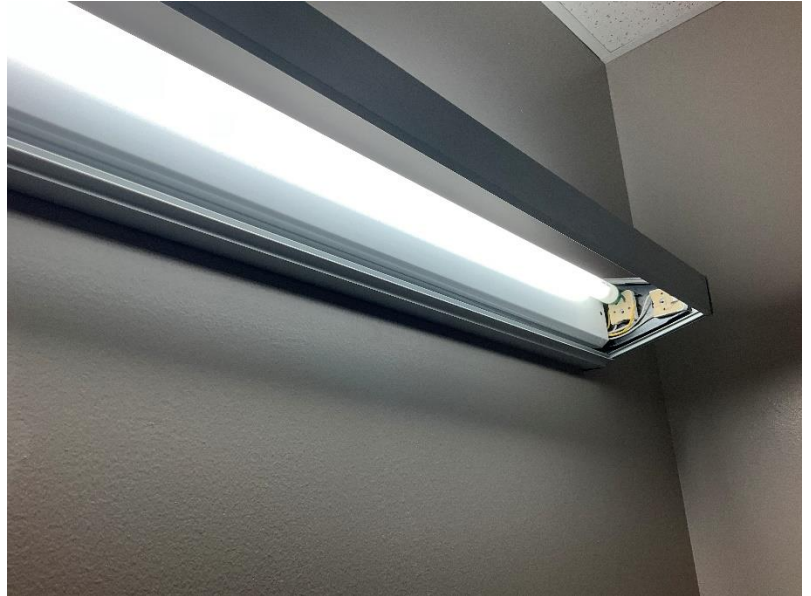
PHOTO E5

- Some of the existing fluorescent light fixtures were noticed having cracked, damaged, or missing lenses and missing lamps. (Photo E5 and E6).
- Linear T12 fluorescent lamps are being utilized in the garage areas and kitchen. Replacement lamps are no longer being manufactured and are obsolete. The existing T12 fixtures in the kitchen do not have vapor tight lenses or shatter proof lamps required per National Sanitation Foundation (NSF) safety regulations.

Fluorescent light fixtures with cracked, damaged, or missing lenses and missing lamps.

- Replace fluorescent light fixtures throughout the facility that are broken or damaged.
 - Clean existing light fixtures that contain debris, dirt, or insects.

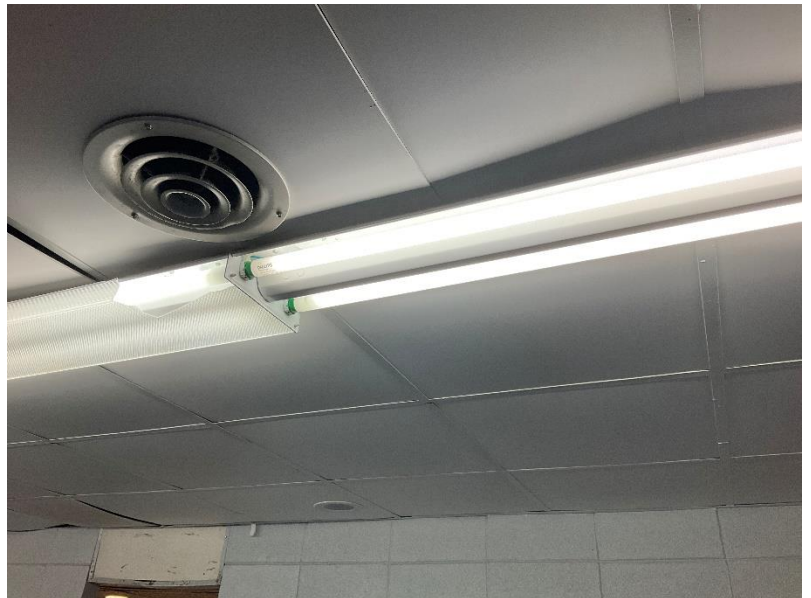
PHOTO E6

Fluorescent light fixtures with cracked, damaged, or missing lenses and missing lamps.

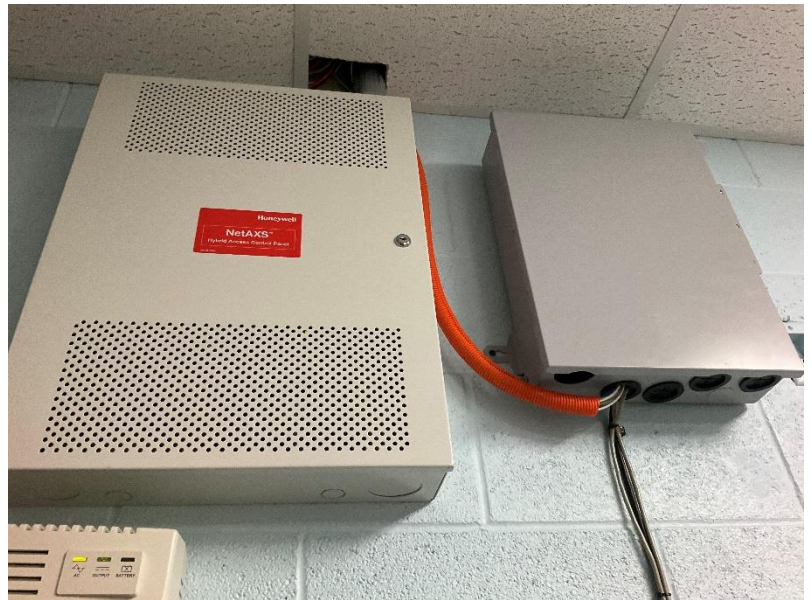
PHOTO E8

- Separate Altronix and Honeywell NetAXS security and access control panels were observed on site. (Photo E8).
- Existing keypads or card readers are located at primary entrances, but not at every exterior door.
- There are surveillance cameras installed within the interior corridors and lobbies. Cameras were also observed on the building exterior. Coverage is adequate for the size of building.
- There is no secured entrance location into the facility or two-way video intercom system near the administration area.

DESCRIPTION:
Existing Access Control Panel.
